FOLLOWING THE STANDARDS, FOLLOWING THE STRUCTURES – THE CASE OF LOUHISAARI CASTLE MID 17TH CENTURY ROOF STRUCTURES

P. SAARINEN¹, M. HUTTUNEN¹, L. LAINE¹ and P. SAVOLAINEN¹

¹ Aalto University, Helsinki

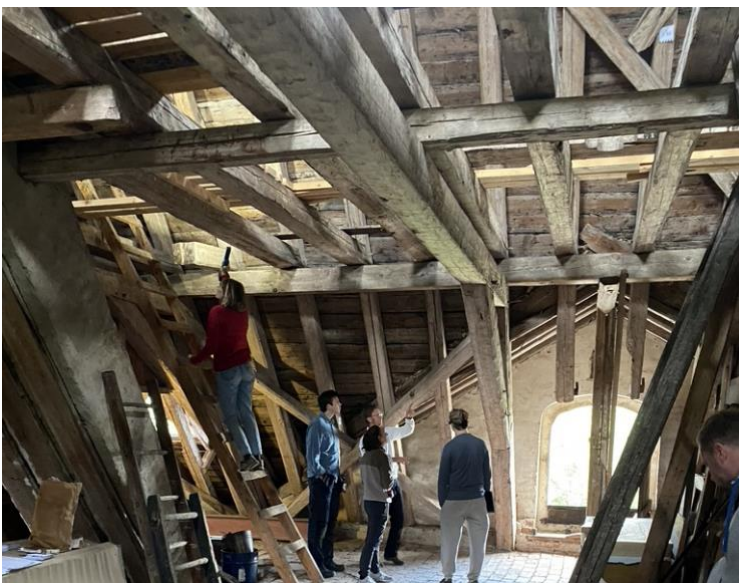
Figure 1: Timber roof structures of Louhisaari Castle. Photo: Panu Savolainen.
