Savolainen, Panu; Seppänen, Liisa; Laine, Laura; Huttunen, Marko; Aakala, Tuomas
Revealing the Innovations in Late Medieval Roof Structures of Finland

Published in:
International Journal of Wood Culture

Revealing the Innovations in Late Medieval Roof Structures of Finland

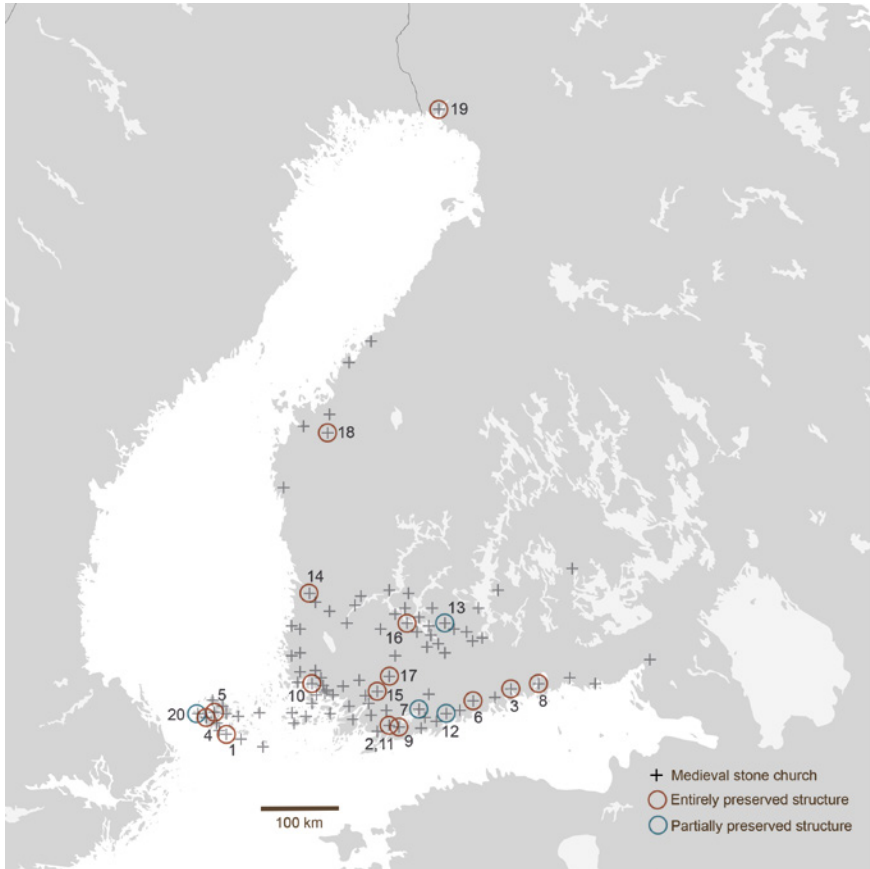
FIGURE 1 Medieval stone churches of Finland with entirely and partially preserved original roof structures. The numbers refer to Table 1
 MAP: LAURA LAINE & PANU SAVOLAINEN

The construction of masonry churches was led by the diocese of Turku, which now covers the southwestern part of present-day Finland. The construction period of medieval stone churches extended from the end of the 13th century to the mid-16th century with a clear boom in the mid-15th century (Hiekkänen 1994, 2007, 2020; Ringbom 1994, 2010; Ringbom *et al.* 1996; Uotila 1998; Seppänen & Ihr 2021). Overall, there are 104 identified medieval stone church projects in Finland so far, mainly in the southern part of the country. Some of these churches have been ruined, and over 30 of them were not finished because the Lutheran reformation ceased the construction of churches from the 1520s onwards. Owing to fires and other destructions and renovations, only about 15–20% of the churches contain original medieval roof constructions preserved until the present (Fig. 1).
